Monitoring of Marseilles Dam Submersible Gates, Illinois River, Illinois

November 2001

Final report

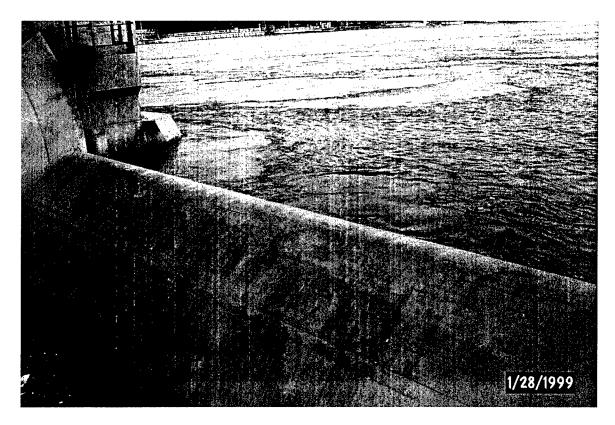
Figure 11. Submersible gate at Marseilles Dam in underflow mode

The new submergible gates are fully enclosed front and back and therefore less prone to ice buildup than the old gates. Also the gate arms are angled away from the pier walls with the clearance distance increasing moving away from the trunnions and towards the gate face. Running in submerged mode, spray icing and seal leakage do not result in ice buildup. During periods of extreme cold, the gates are moved or cycled every 2 hr to prevent freezing. Figure 11 shows one of the new gates at Marseilles Dam.

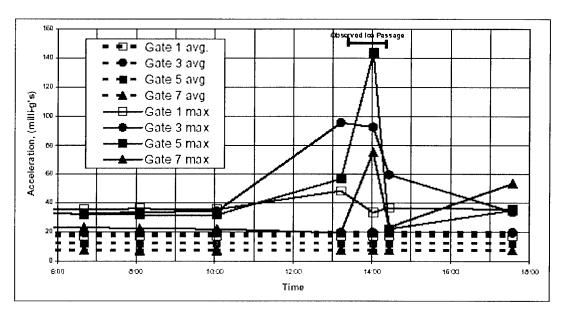
Figure 32. Maximum gate accelerations, 28 January 2000

By the next morning, 26 January, thin black ice had reformed on the pool. This cover remained in place until about 13:00 on 28 January when strong easterly winds flooded the ice cover's upstream edge and moved the sheet towards the dam. Within half an hour, most of the ice on the pool had moved past the central gates on the dam, which were submerged 0.2 m (0.5 ft) at the time. The greatest accelerations, in the 95 to 145 milli-g range, occurred at centrally located Gates 5 and 3 (Figure 32).

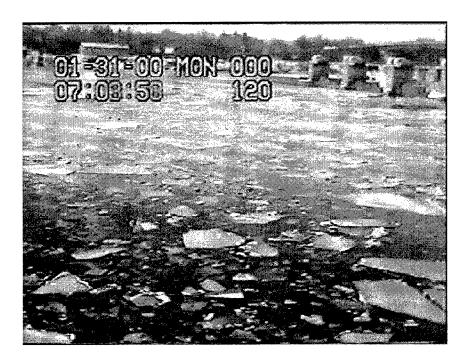
Figure 33. Fragmented ice in pool, morning of 31 January 2001

During 29 and 30 January, the pool was open, with intermittent disperse floes passing. At dawn on the morning of 31 January, fractured floes filled the image area (Figure 33) At this time the gate openings were even at 0.4 m (1.5 ft). At 07:17, strong westerly winds caused the ice on the left side of the pool to shift upstream. At 07:27 the ice floes on the left side of the pool moved downstream and began to pass Gates 1 and 2. Between 07:30 and 07:50, the ice on the right hand side of the pool began moving, and at 07:50, the central ice moved. After 08:04, the pool was, for the most part, ice-free.

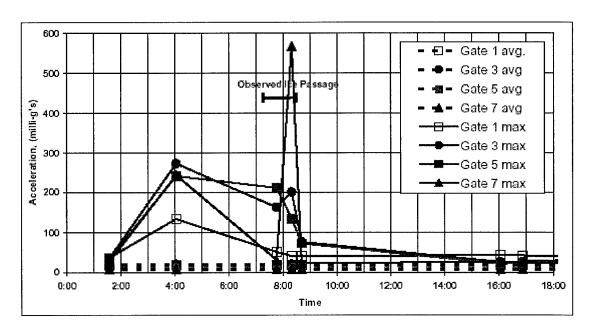
Figure 34. Maximum gate accelerations, 31 January 2000

08:00, the maximum acceleration for Gate 7 was 570 milli-g's. Because Gate 7 lies outside of the image area, it is unclear what caused this high value.

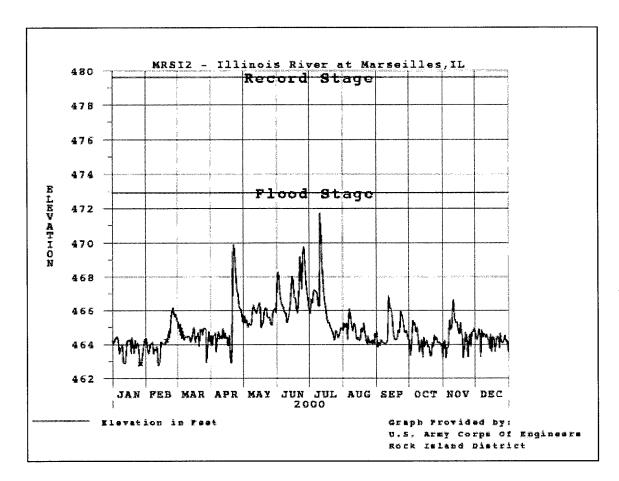
Figure 40. Time-history Illinois River stages at Marseilles

For periods when a significant rise in river stage occurs, as indicated in Figure 40 between the periods April – July 2000, multiple gate operations are required to pass the inflows. These gate operations are characterized by larger raised gate openings 1.5 - 2.1 m (5.0 - 7.0 ft) for longer periods of time (days) to maintain the upper pool water levels.

A significant rise in river stage occurred, as indicated in Figure 40, between the periods April – July 2000, and required multiple gate operations to pass the inflows. These gate operations are characterized by larger raised gate openings 1.5 - 2.1 m (5.0 - 7.0 ft) for longer periods of time (days) to maintain the upper pool water levels.

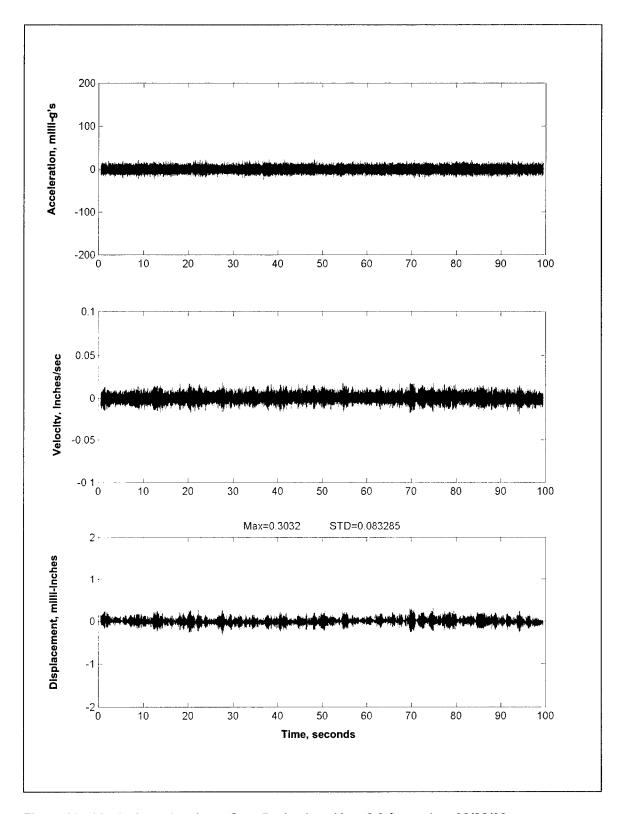
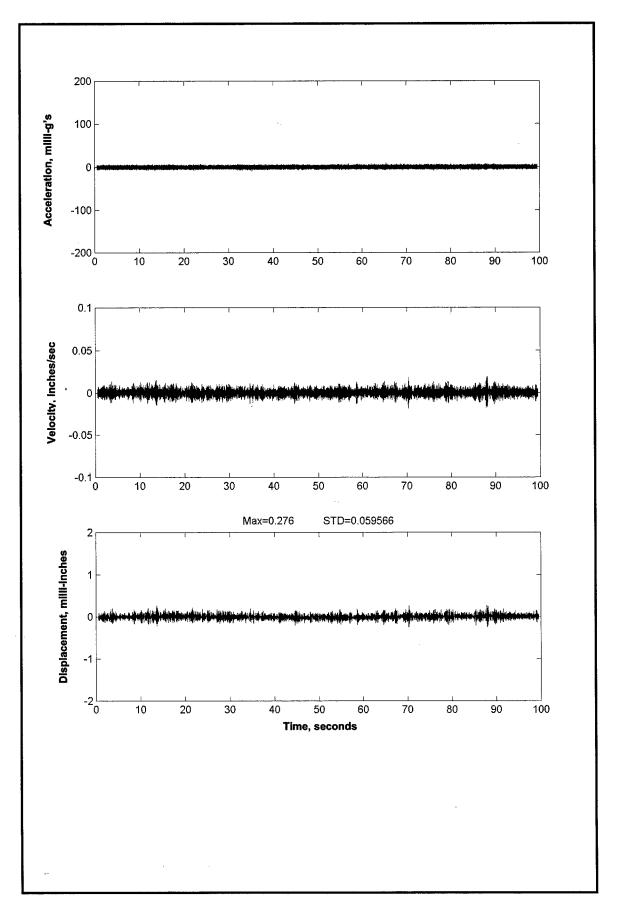
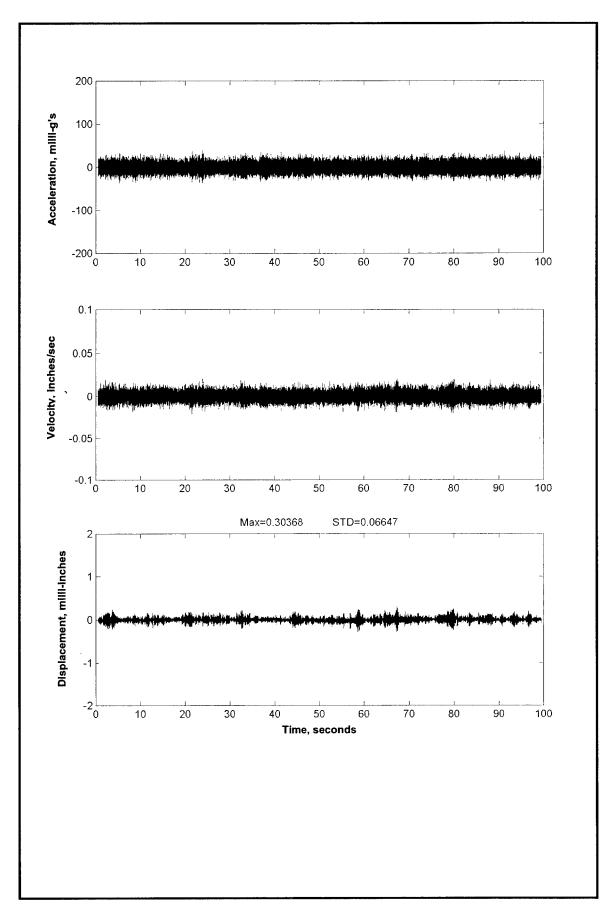
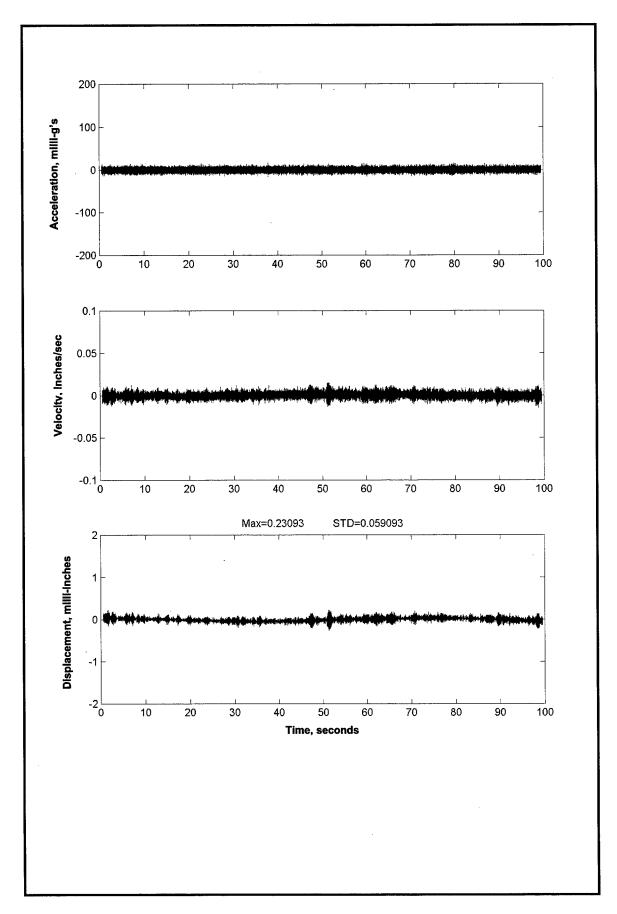
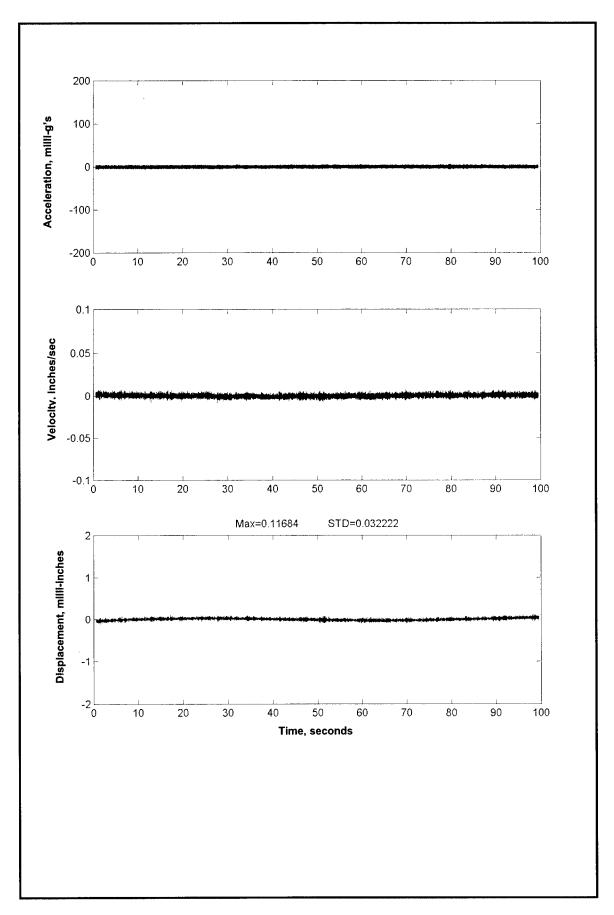
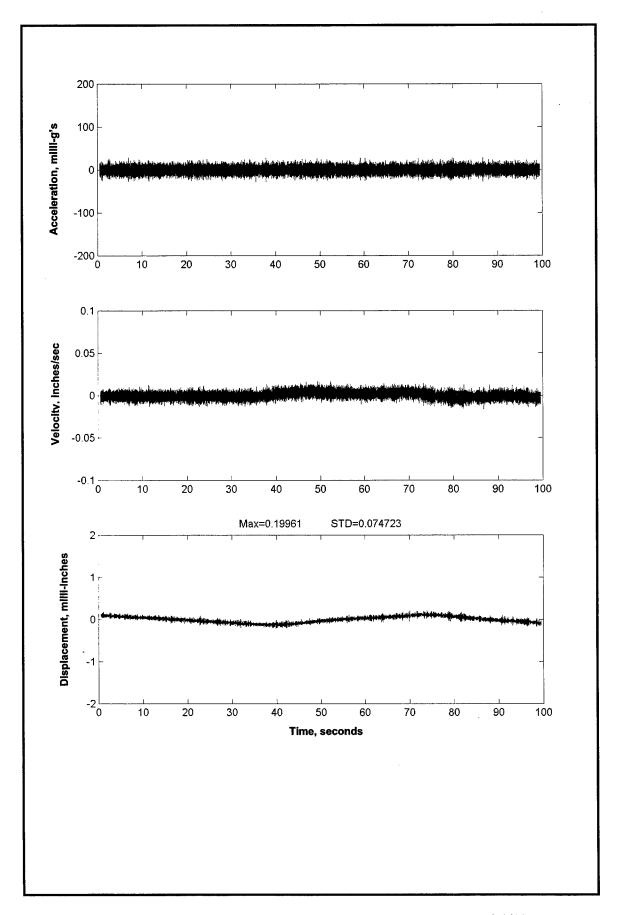
The summaries of vibration levels recorded for the various instrumented gates operated at the larger openings during this period are presented in Tables 15–19. Tables 15-16 and Figures 41 - 52 are representative sampling of vibration levels occurring with two-gate operation for gate openings ranging from 0.6 - 1.5 m (2.0 – 5.0 ft). Tables 17- 19 and Figures 53 - 79 are a representative sampling of the vibration levels occurring with a three-gate operation and gate openings ranging from 0.3 - 2.1 m (1.0 – 7.0 ft). The maximum values of vibration level and displacement observed during these operations were 0.20 g's and 0.005 cm (0.002 in.), respectively. These values represent the predominant vibration levels and displacements to which the gates are subjected for the particular gate openings during a particular segment of time and indicate that very insignificant movement is occurring for these raised gate operation conditions.

The vibration levels indicated that for these raised gate operation conditions very insignificant gate movement is present. The maximum vibration level values and displacement observed during these operations were 0.20 g's and 0.005 cm (0.002 in.), respectively.

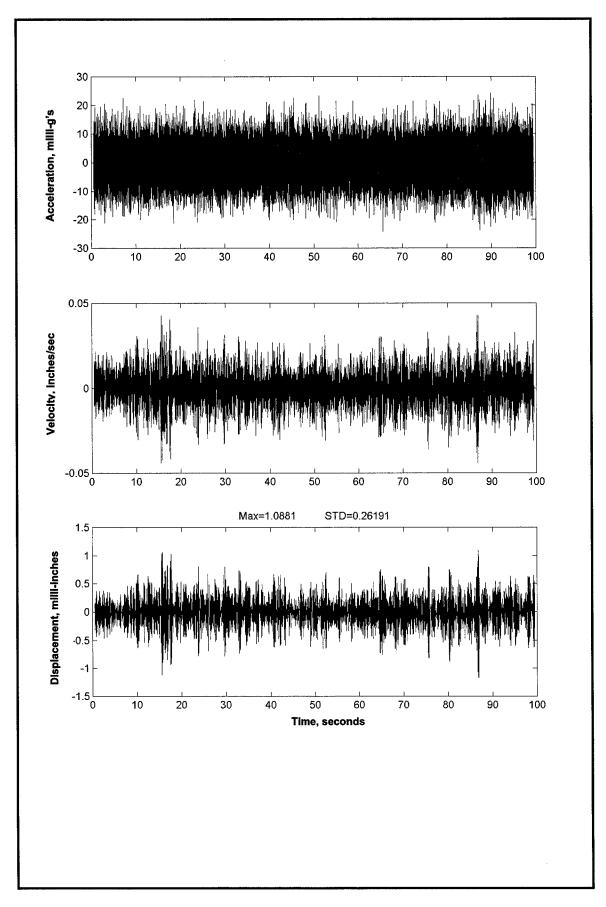
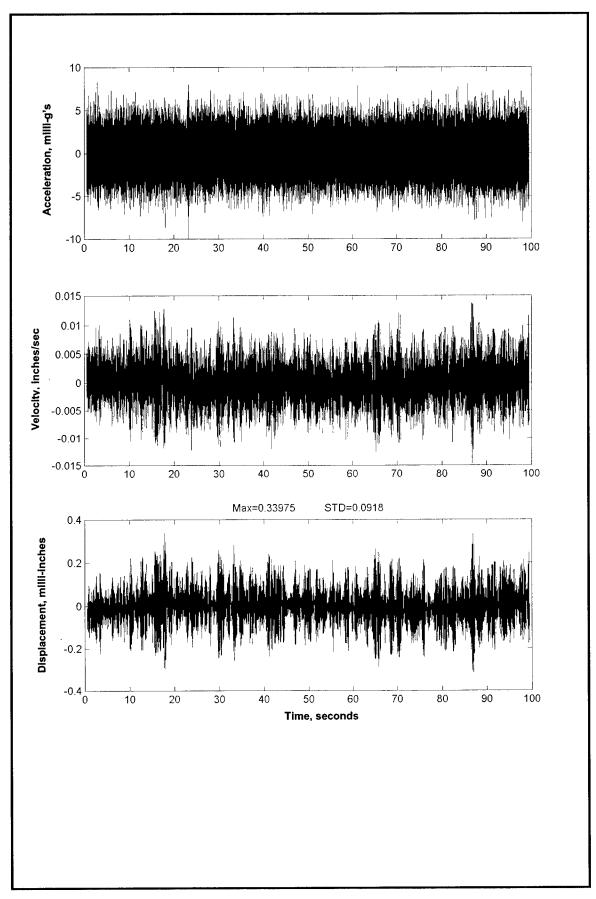
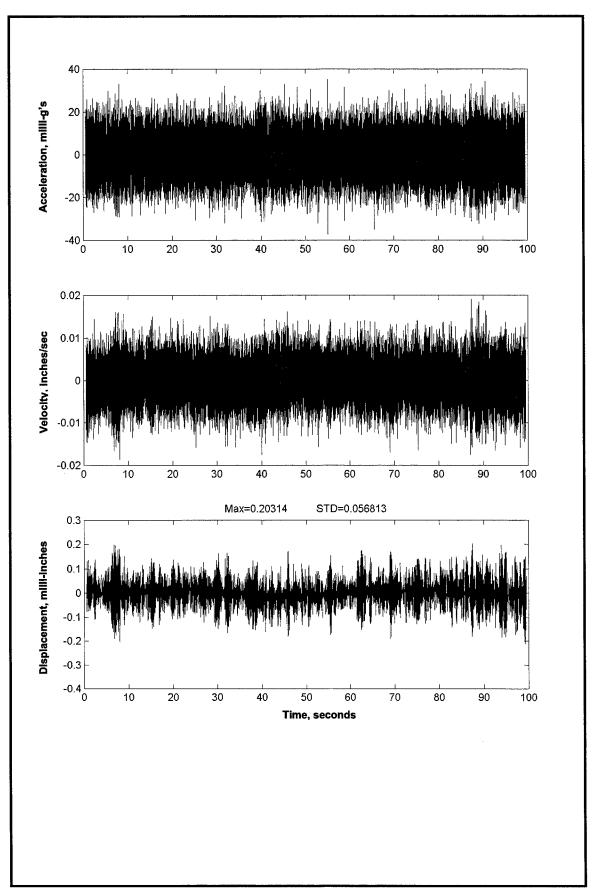
In general the vibration levels and displacements were extremely small (less than 0.3 g's and less than 0.002 cm (0.001 in.), respectively). Tables 21-23 and Figures 80 - 82 are a representative sampling of the vibration levels occurring with a four-gate submerged operation and gate openings ranging from 0.4 - 0.6 m (1.5-2.0 ft). The maximum values of vibration level and displacement observed during these operations were 0.06 g's and 0.005 cm (0.002 in.), respectively. These values represent the predominant vibration levels and displacements to which the gates are subjected for the particular gate openings during a particular segment of time and indicate that very insignificant movement is present for these submerged gate operation conditions.

Vibration levels were found to increase with four-gate submerged operation and gate openings ranging from 0.4 - 0.6 m (1.5 - 2.0 ft). The maximum values of vibration level and displacement observed during these operations were 0.06 g's and 0.005 cm (0.002 in.), respectively. The values represent very insignificant movement for these submerged gate operation conditions.
